# Infrared Inspection

## Infrared Thermography Inspection

**40 Year Recertification**

Thermographer	Humberto Suarez
Company Name	Evolve Property Inspections
Client	Sample
Inspection Date	03/24/2022
Address	Sample
Report Name	Electrical Thermography

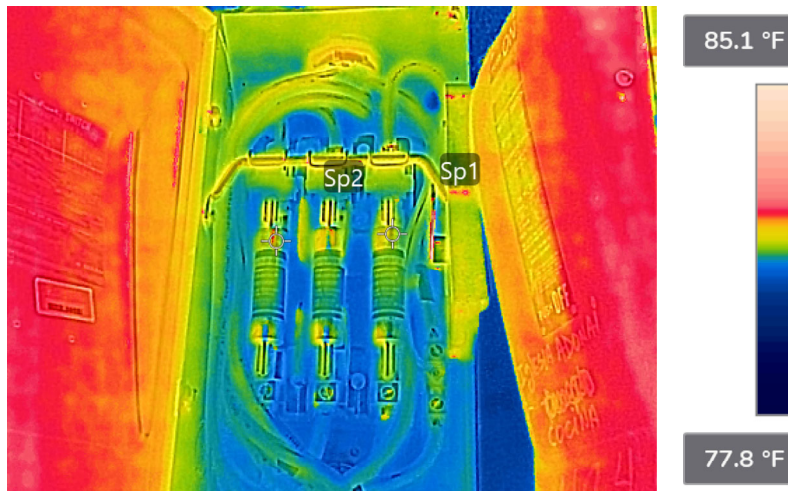
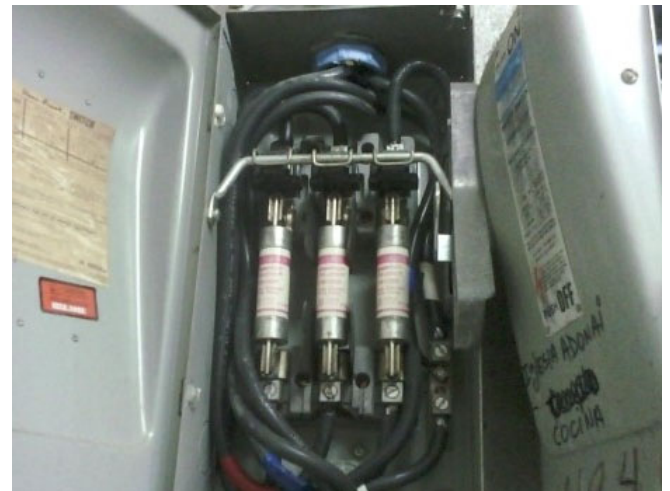
Floor	1
Location	Electrical Room
Equipment	Main switch gear
Item	11948 iglesia
Details	Y
Anomaly	Normal
Recommendation	No action

**No heat rise. Higher temperature is reflected from inspector's body**

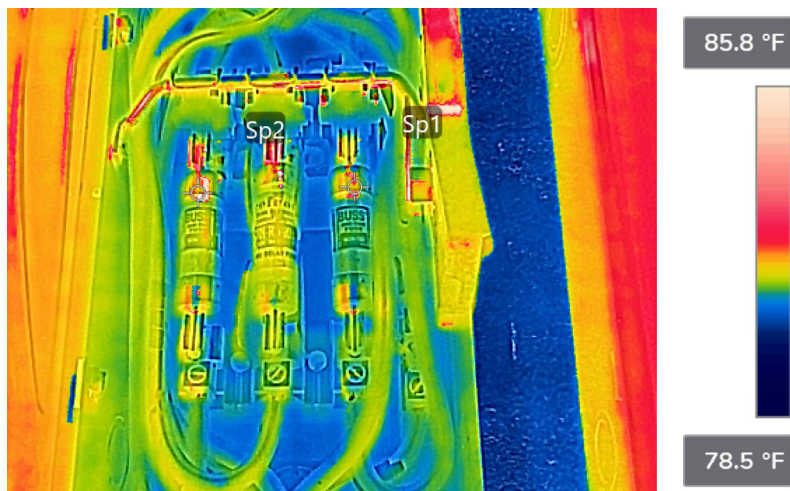
Floor	1
Location	Electrical Room
Equipment	Main switch gear
Item	11946 iglesia
Details	Y
Anomaly	Normal
Recommendation	No action

**No heat rise. Higher temperature is reflected from inspector's body**

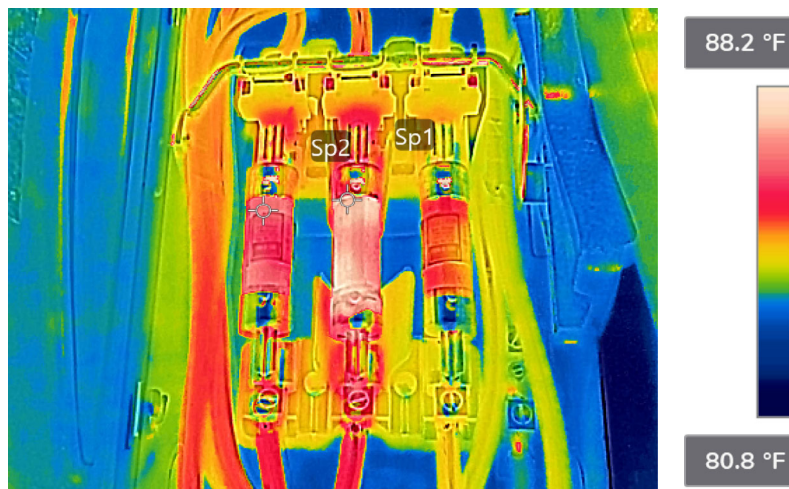
Floor	1
Location	Electrical Room
Equipment	Main switch gear
Item	11944
Details	Y
Anomaly	Normal
Recommendation	No action

**No heat rise. Higher temperature is reflected from inspector's body**

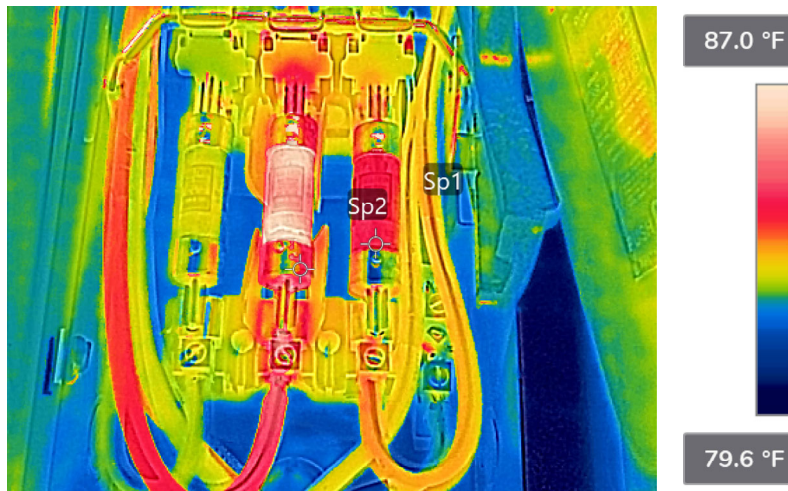
Floor	1
Location	Electrical Room
Equipment	Main switch gear
Item	11942
Details	Y
Anomaly	Normal
Recommendation	No action

**No heat rise. Higher temperature is reflected from inspector's body**

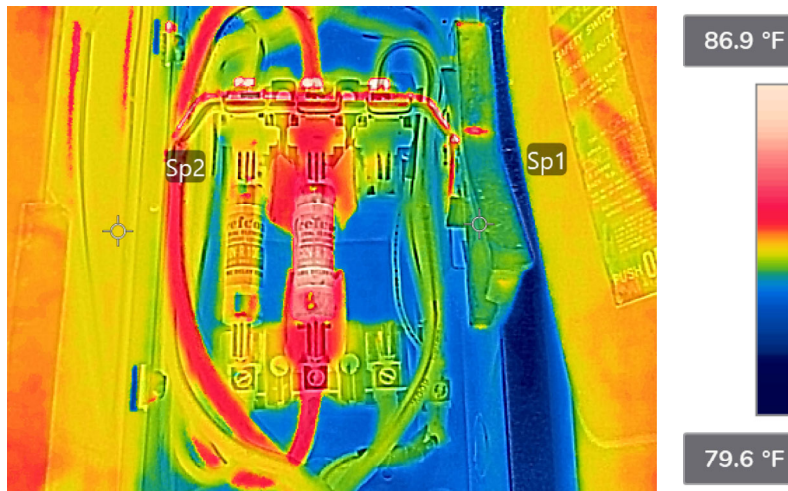
Floor	1
Location	Electrical Room
Equipment	Main switch gear
Item	11940
Details	Y
Anomaly	Normal
Recommendation	No action

**Missing/damaged Fuses Phase C, Recommend electrical contractor instal new fuses 100 amp**

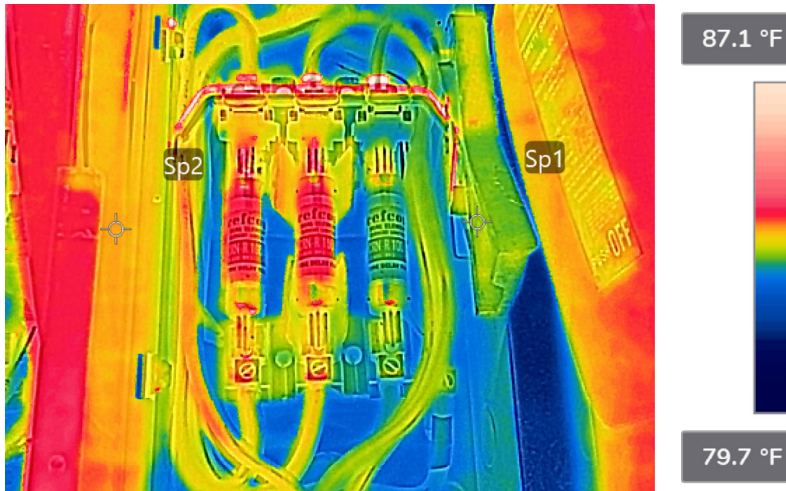
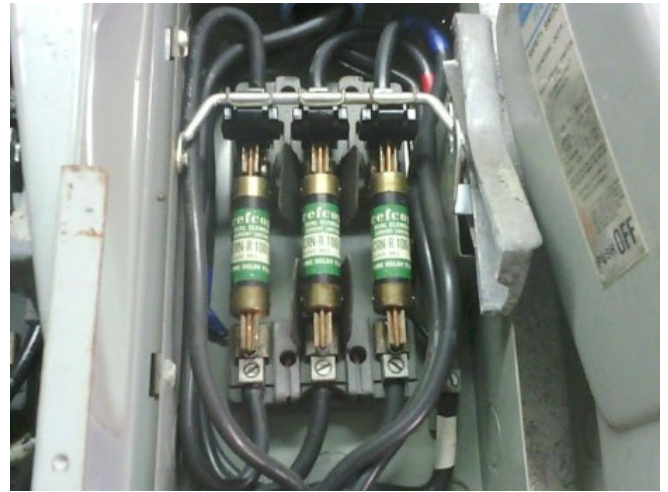
Floor	1
Location	Electrical Room
Equipment	Main switch gear
Item	11938
Details	Y
Anomaly	Normal
Recommendation	No action

**No heat rise. Higher temperature is reflected from inspector's body**

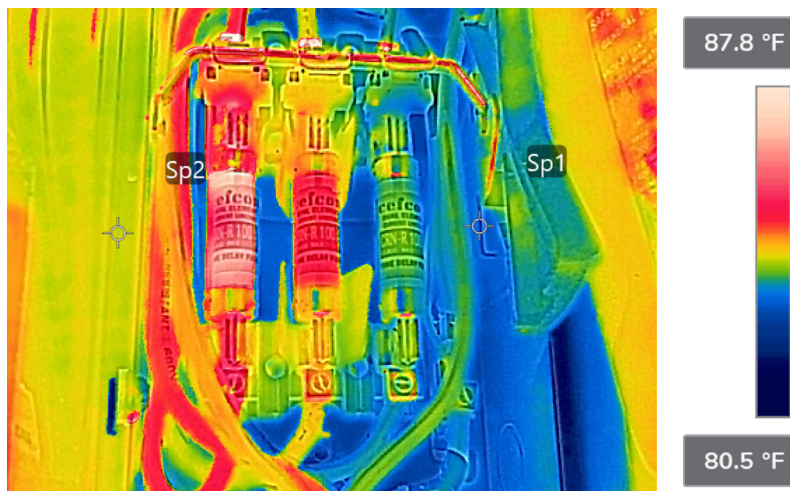
Floor	1
Location	Electrical Room
Equipment	Main switch gear
Item	11936
Details	Y
Anomaly	Normal
Recommendation	No action

**No heat rise. Higher temperature is reflected from inspector's body**

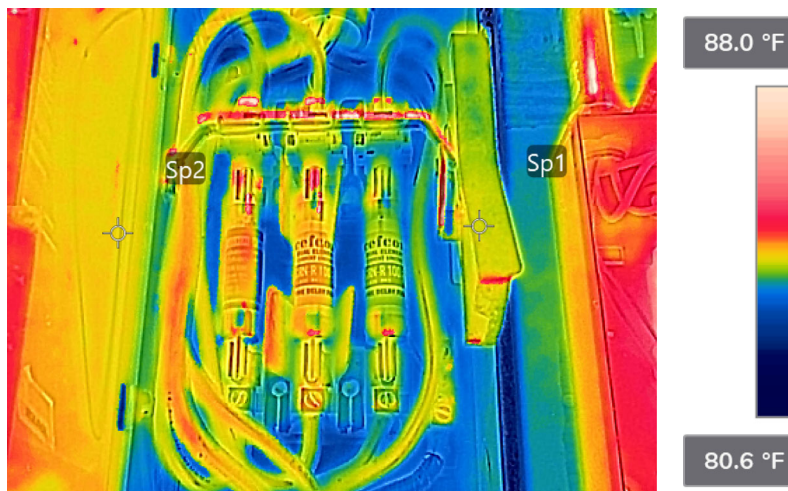
Floor	1
Location	Electrical Room
Equipment	Main switch gear
Item	11934
Details	Y
Anomaly	Normal
Recommendation	No action

**No heat rise. Higher temperature is reflected from inspector's body**

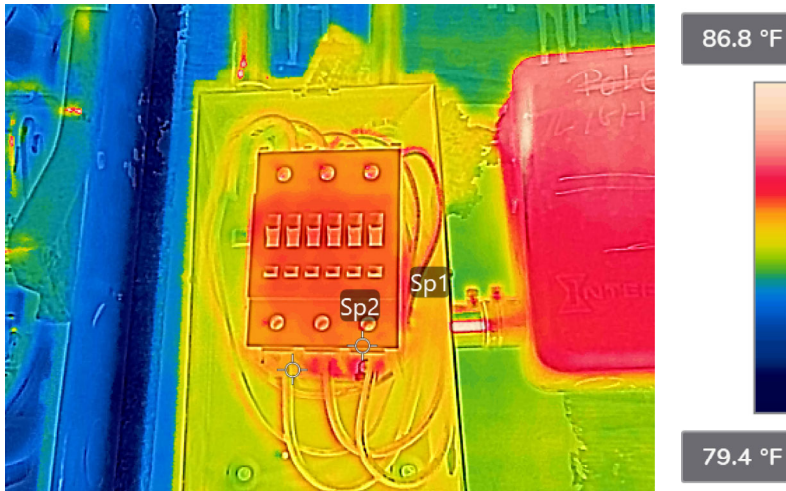
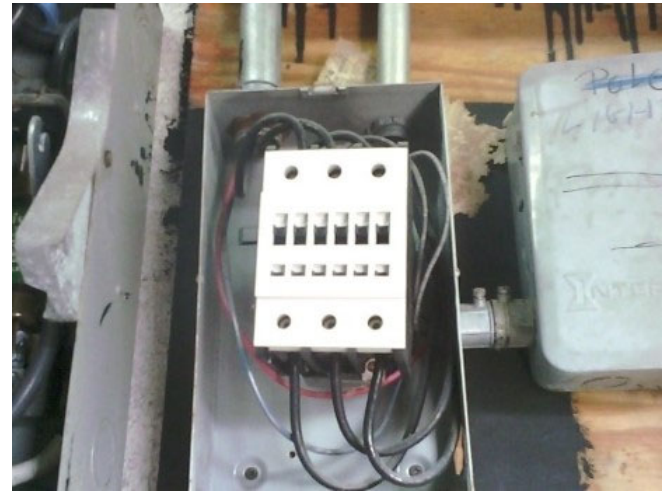
Floor	1
Location	Electrical Room
Equipment	Light post contactor
Item	1st
Details	Y
Anomaly	Priority
Recommendation	Contactor is exposed and in the wrong box

**Contactor is exposed and in the wrong box, Recommend electrical contractor to replace to proper lighting contactor**

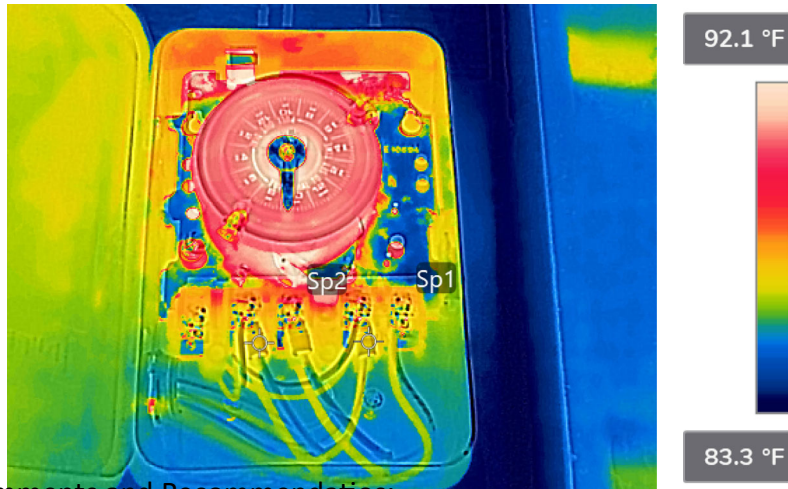
Floor	1
Location	Electrical Room
Equipment	light pol timer
Item	Exterior lightning
Details	Y
Anomaly	Normal
Recommendation	No action

**No heat rise. Higher temperature is reflected from inspector's body**

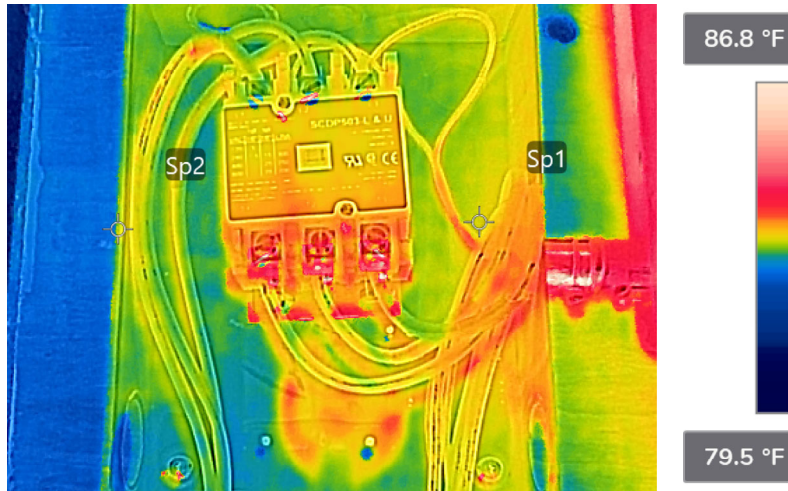
Floor	1
Location	Electrical Room
Equipment	Light signs contactor
Item	Exterior sign
Details	Y
Anomaly	Normal
Recommendation	No action

**Knockouts - Missing Knockout seals electrical equipment has exposed energized access, person or object may suffer electrocution if in contact with opening in contactor box, Recommend by code all knockouts should be installed. Please ask your electrician/engineer to evaluate**

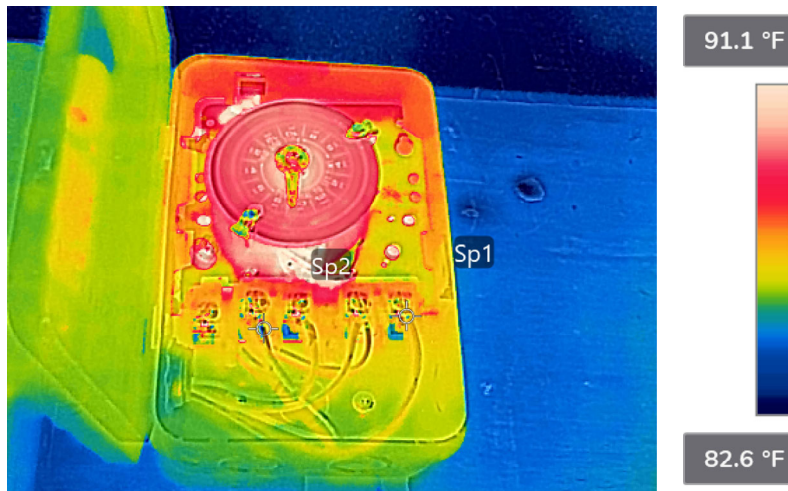
Floor	1
Location	Electrical Room
Equipment	Signs timer
Item	Timer
Details	Y
Anomaly	Normal
Recommendation	No action

**No heat rise. Higher temperature is reflected from inspector's body**

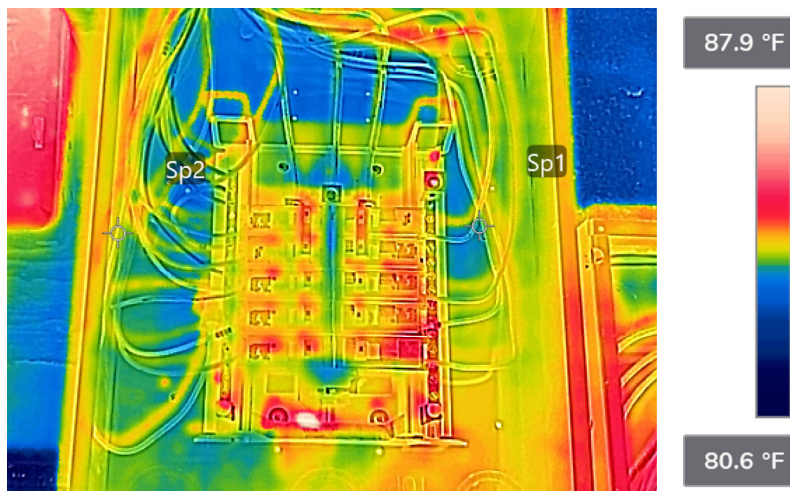
Floor	1
Location	Electrical Room
Equipment	Breaker panel
Item	house panle C
Details	Y
Anomaly	Normal
Recommendation	No action

**Nutral cable not proper color, Please ask your electrician/engineer to check it**

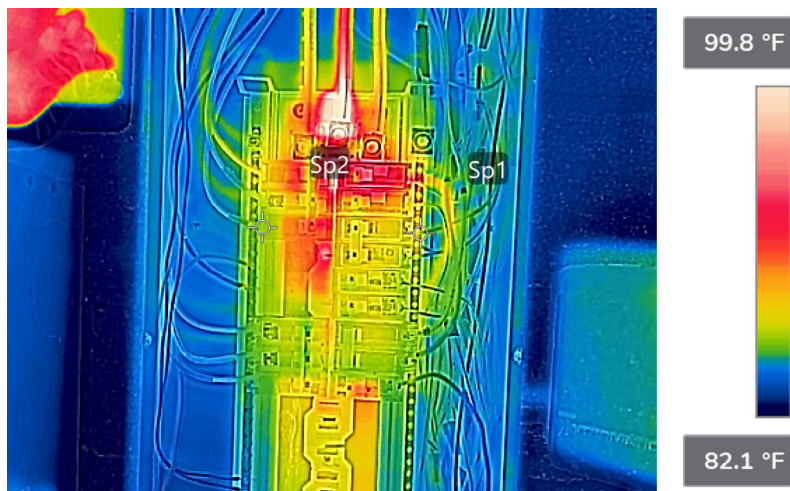
Floor	1
Location	Electrical Room
Equipment	Breaker panel
Item	House panel B
Details	Y
Anomaly	Nutral cable not proper coller
Recommendation	Electrical contractor to repair

**Nutral cable not proper color, Please ask your electrician/engineer to check it**

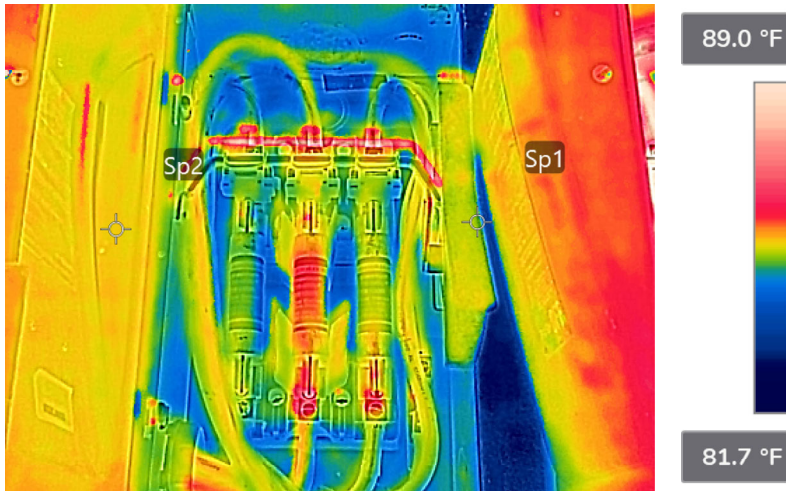
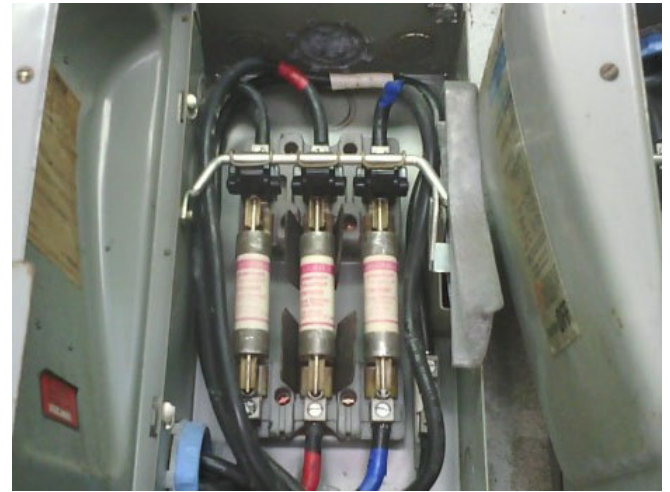
Floor	1
Location	Electrical Room
Equipment	Main switch gear
Item	11918
Details	Y
Anomaly	Normal
Recommendation	No action

**No heat rise. Higher temperature is reflected from inspector's body**

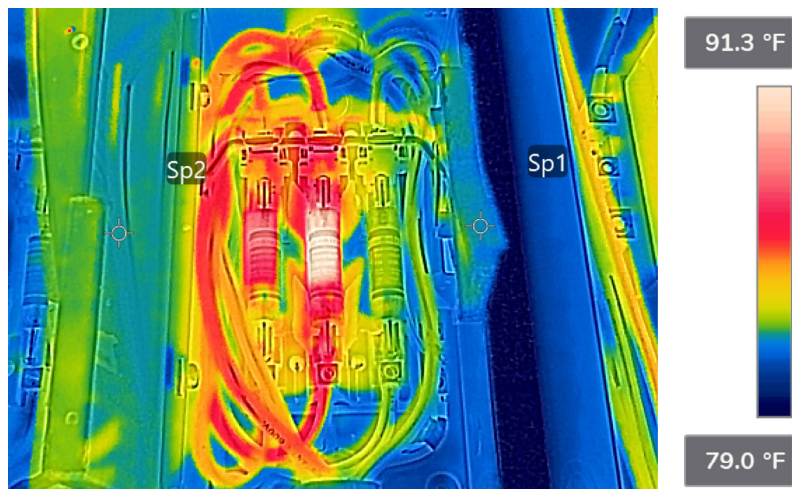
**No heat rise. Higher temperature is reflected from inspector's body**

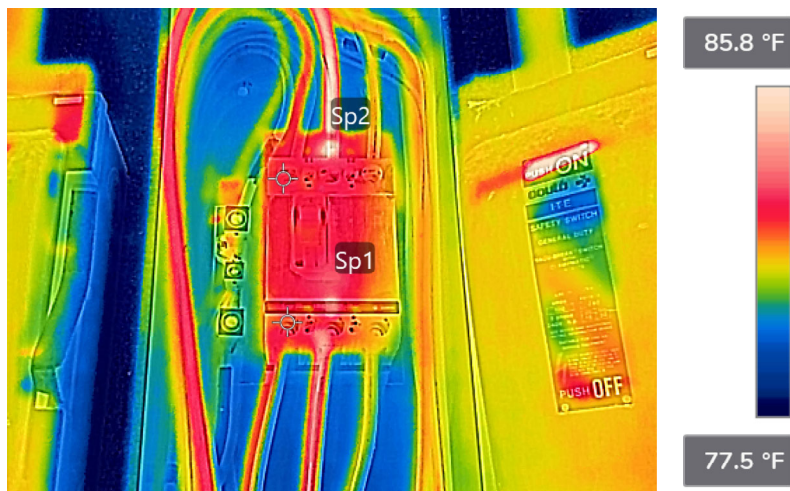
**Light Poll main breaker shut off installed in location were does not allow to access other main shut off by electrical code need clearnce, Recommend electrical contractor to evaluate**

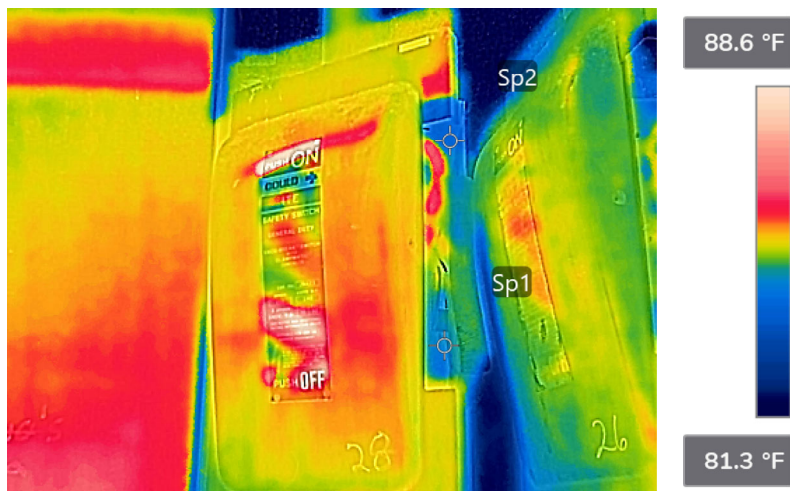
**No Access main breaker shut off installed in location were does not allow to access other main shut off by electrical code need clearnce, Recommend electrical contractor to evaluate a better location or replacemnt**

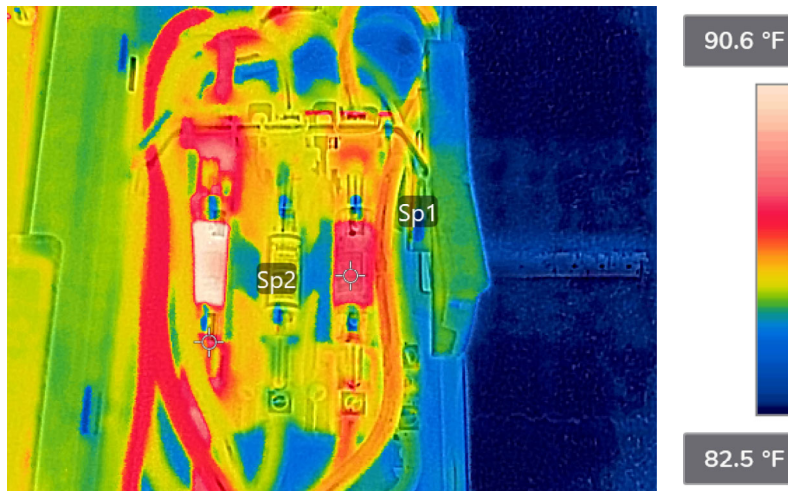
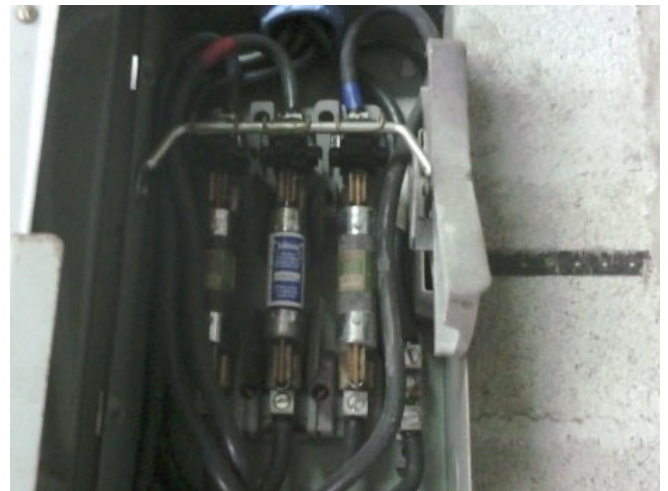
**No heat rise. Higher temperature is reflected from inspector's body**

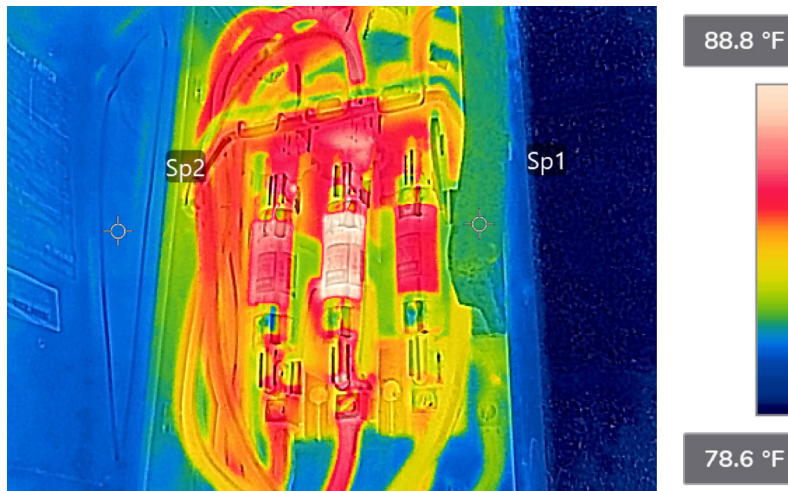
**No heat rise. Higher temperature is reflected from inspector's body**

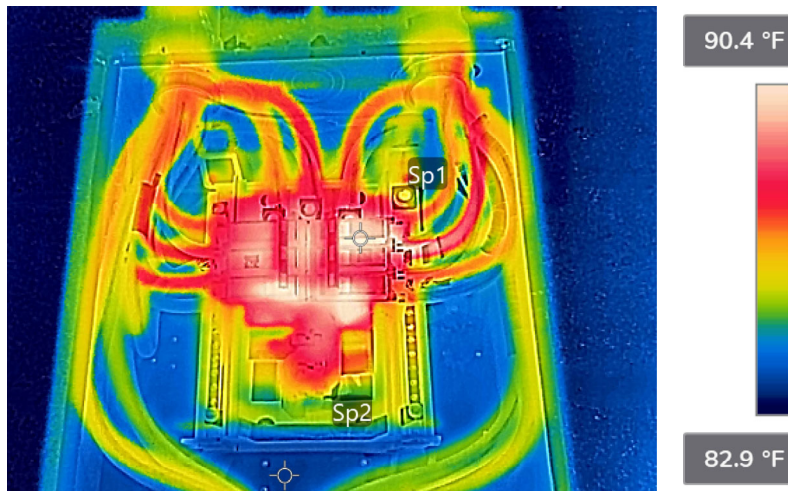
**Installation of 2 main breakers are not properly installed by code, recommend 2 separate main breaker disconnect by a Electrical contractor**

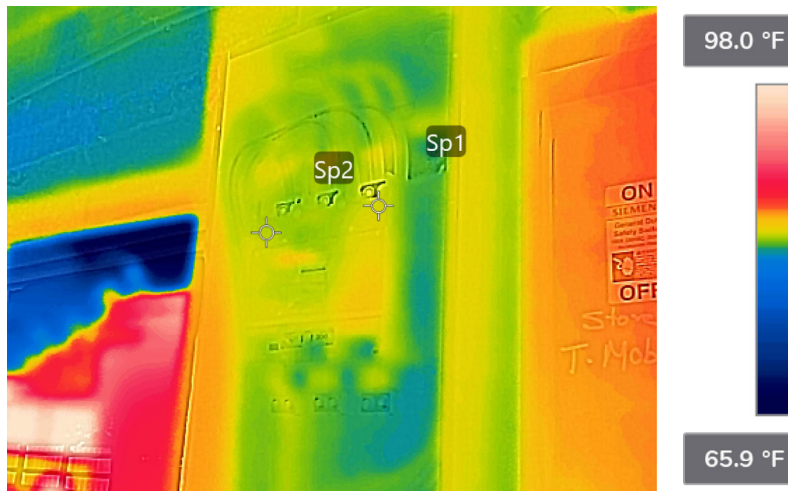
Not in use

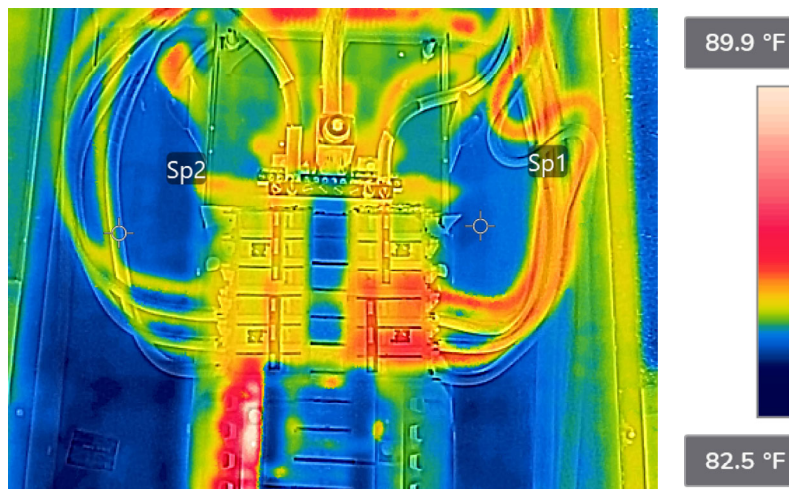
**Knockouts - Missing Knockout seals electrical equipment has exposed energized access, person or object may suffer electrocution if in contact with opening in contactor box, Recommend by code all knockouts should be installed. Please ask your electrician/engineer to evaluate**

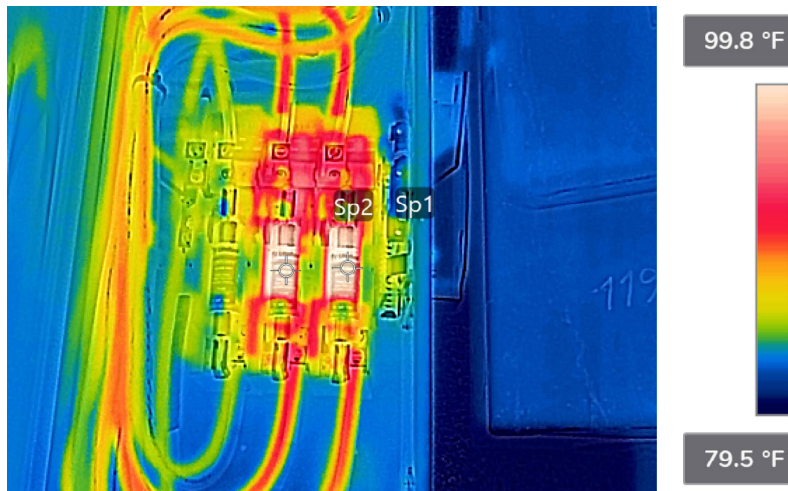
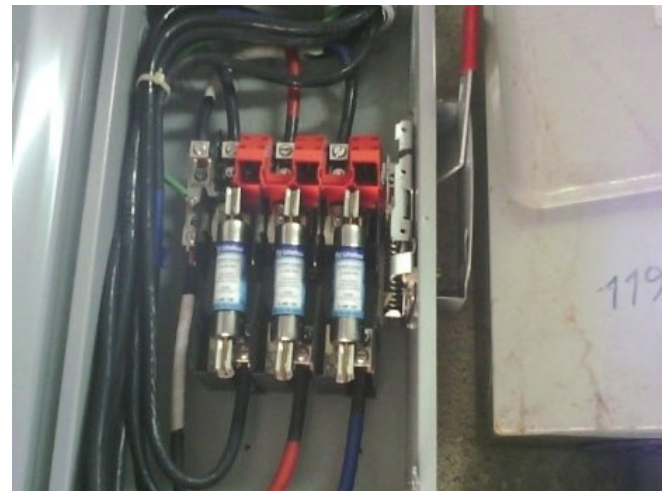
**No heat rise. Higher temperature is reflected from inspector's body**

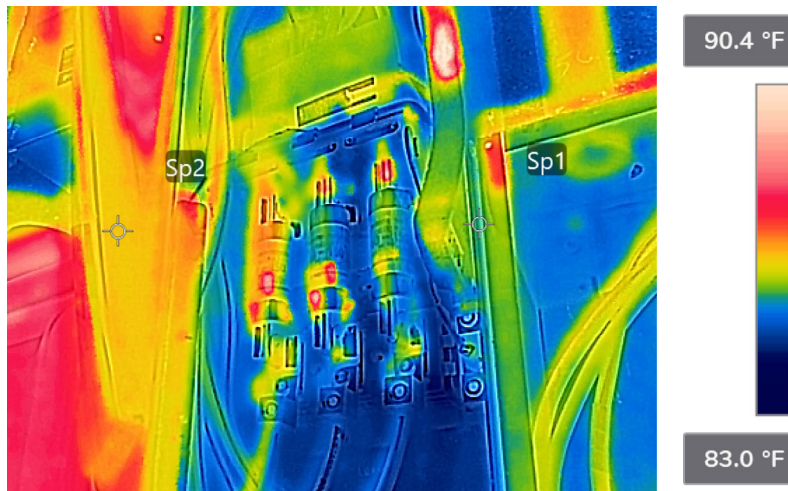
**No heat rise. Higher temperature is reflected from inspector's body**

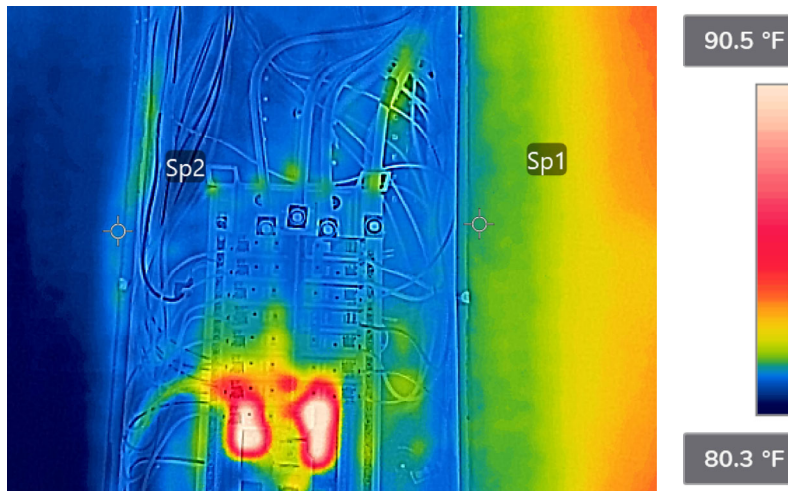
**Grounding Issues, Recommend installing proper grounding bars by a licensed electrician**

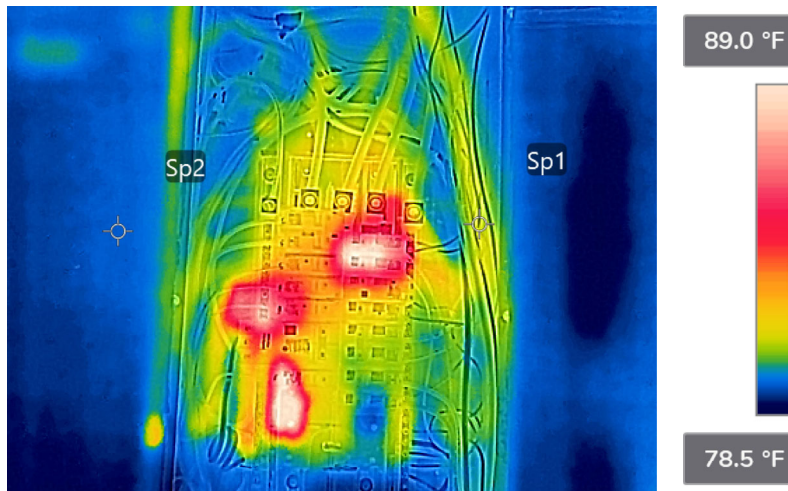
**Grounding Issues, Recommend installing proper grounding bars by a lisencc electrician**

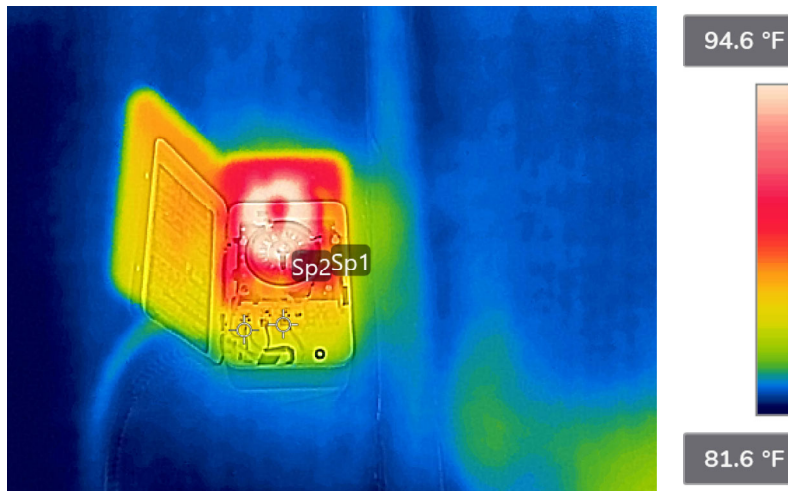
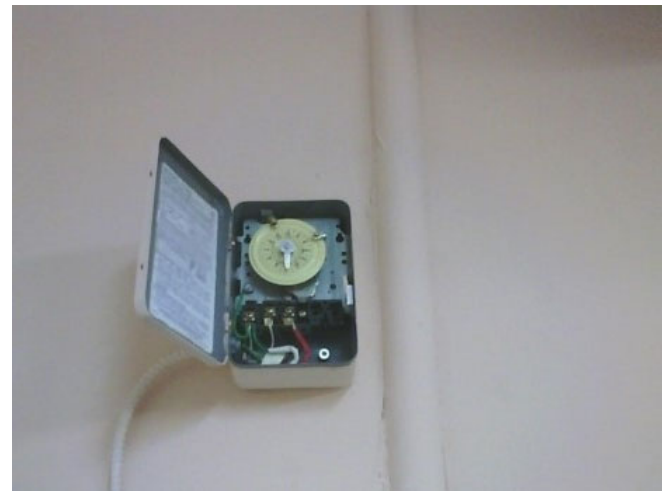
**No heat rise. Higher temperature is reflected from inspector's body**

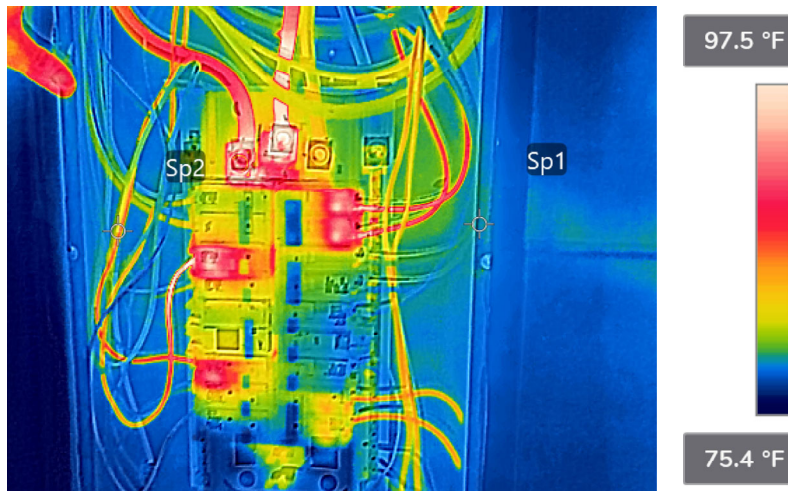
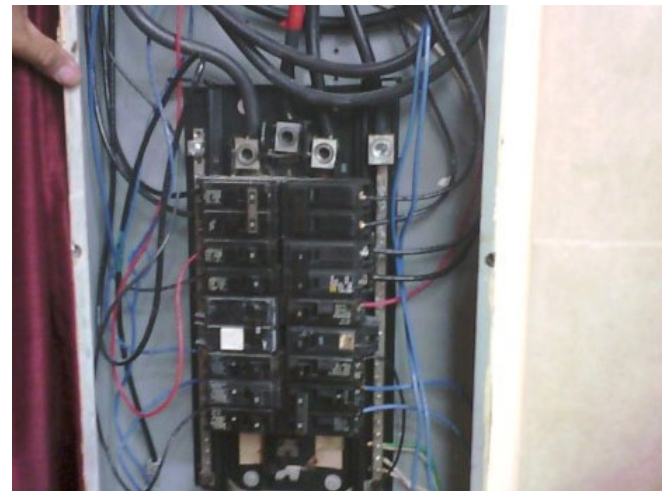
**Grounding Issues and deffrent breakers , Recommend installing proper grounding bars and proper breakers by a lisencc electrican**

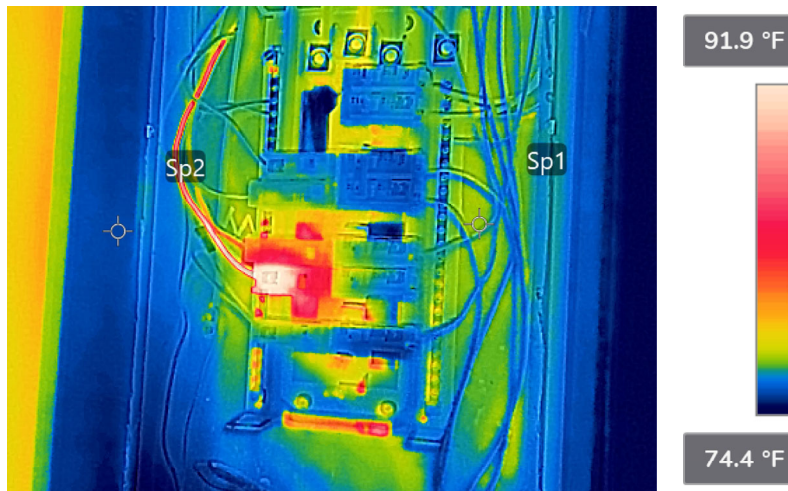
**Doble tapping, wrong breakers no ground and missing C Phase, Recommend liscence electrician to repair**

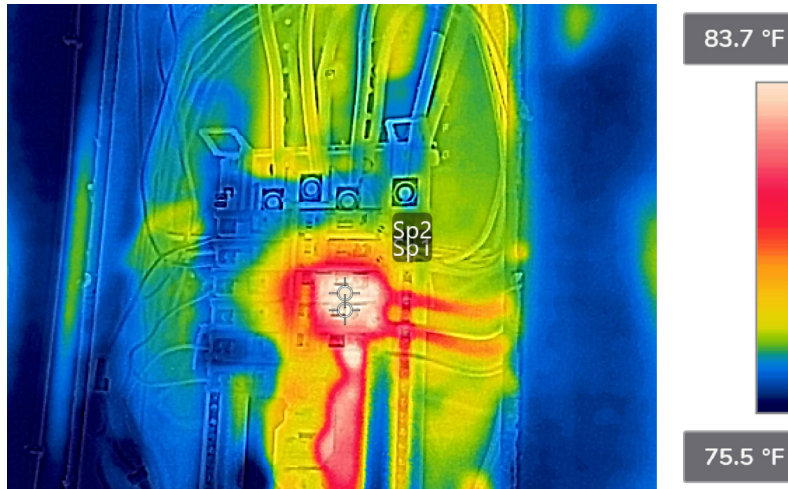
**No heat rise. Higher temperature is reflected from inspector's body**

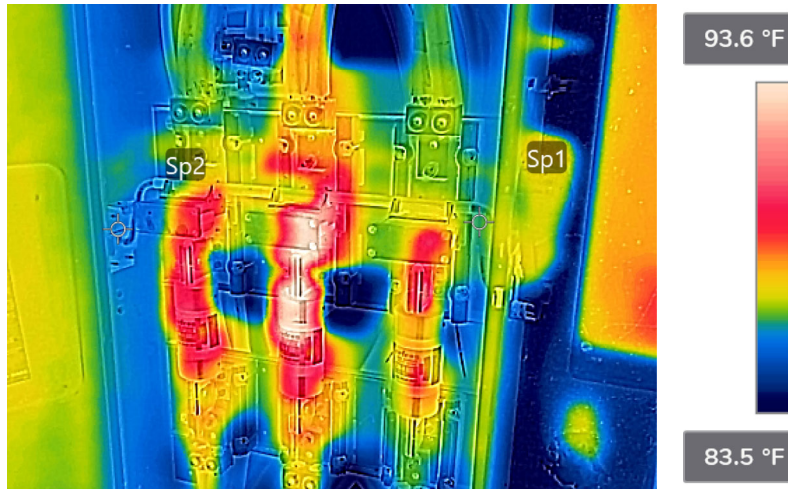
**No heat rise. Higher temperature is reflected from inspector's body**

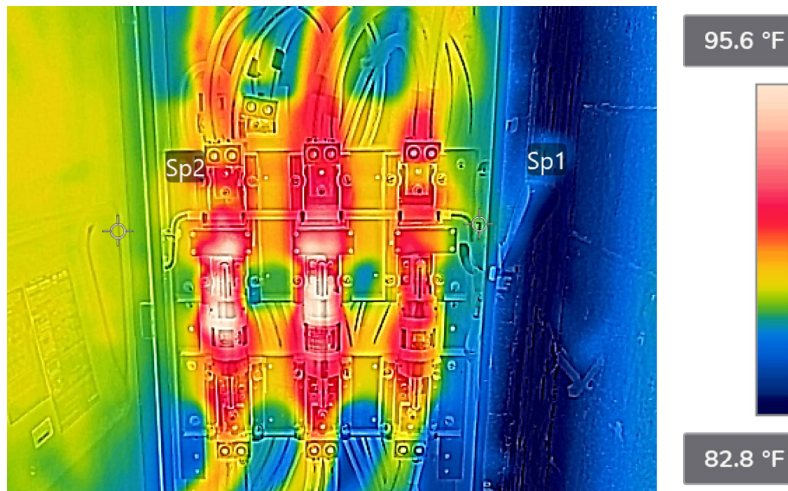
**No heat rise. Higher temperature is reflected from inspector's body**

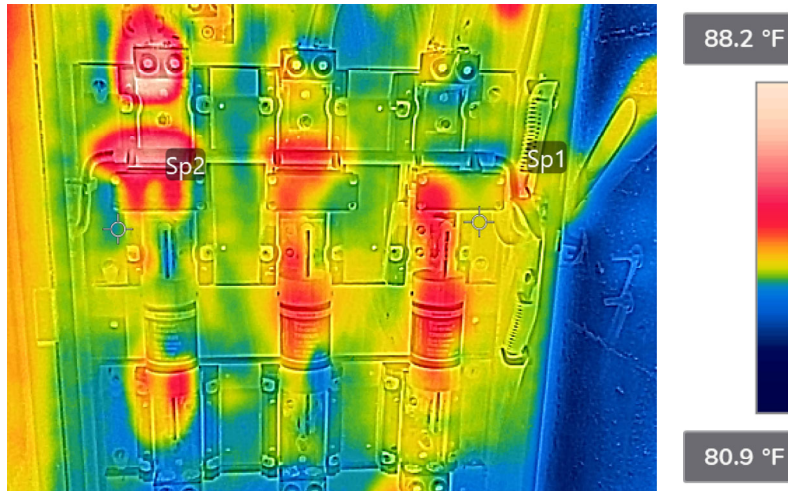
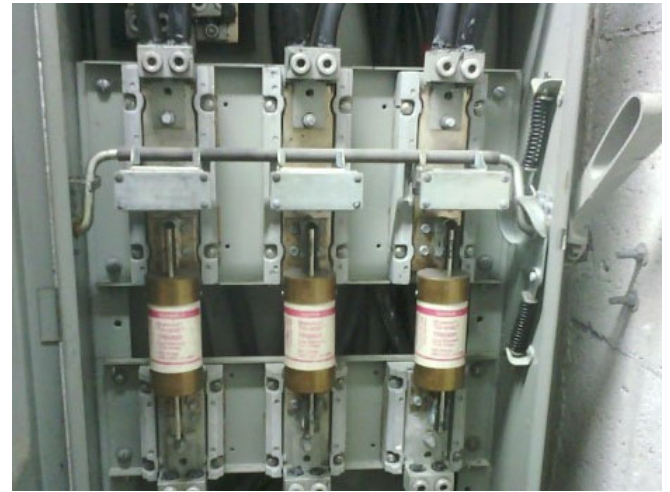
**No heat rise. Higher temperature is reflected from inspector's body**

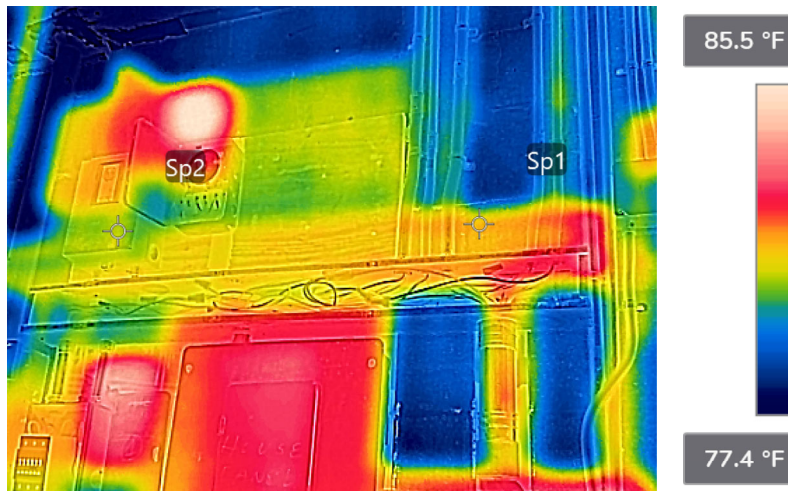
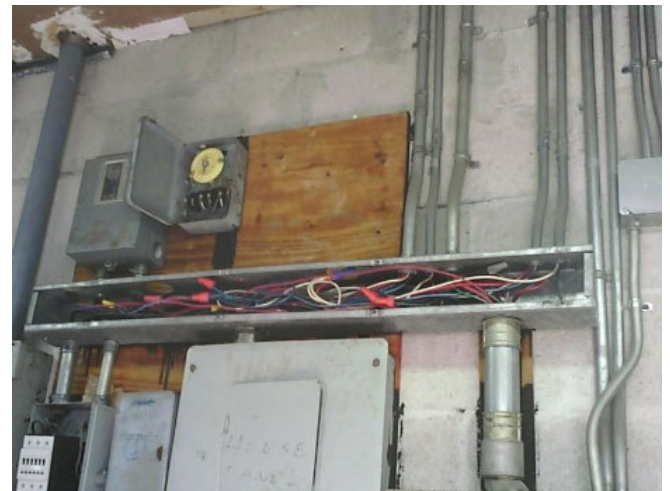
**Knockouts - Missing Knockout seals electrical equipment has exposed energized access, person or object may suffer electrocution if in contact with opening in contactor box, Recommend by code all knockouts should be installed. Please ask your electrician/engineer to evaluate**

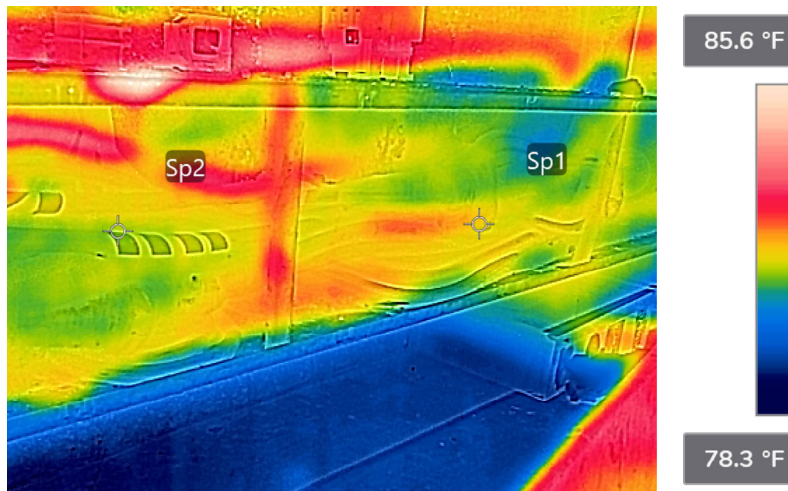
**Knockouts - Missing Knockout seals electrical equipment has exposed energized access, person or object may suffer electrocution if in contact with opening in contactor box, Recommend by code all knockouts should be installed. Please ask your electrician/engineer to evaluate**

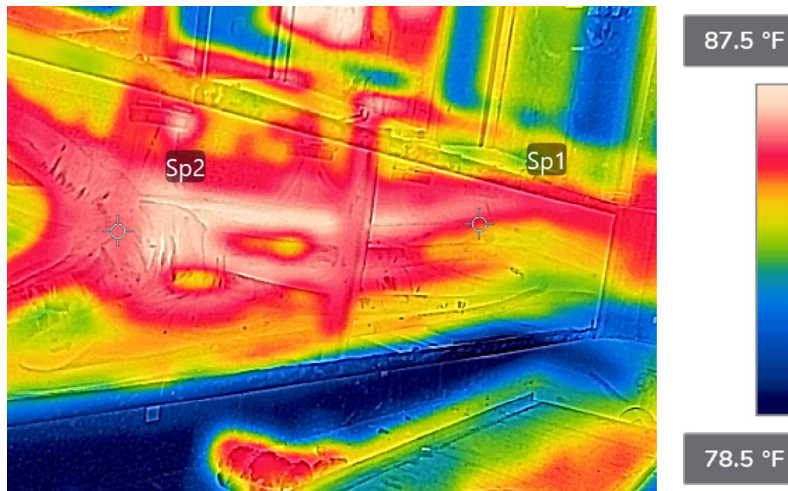
**Knockouts - Missing Knockout seals electrical equipment has exposed energized access, person or object may suffer electrocution if in contact with opening in contactor box, Recommend by code all knockouts should be installed. Please ask your electrician/engineer to evaluate**

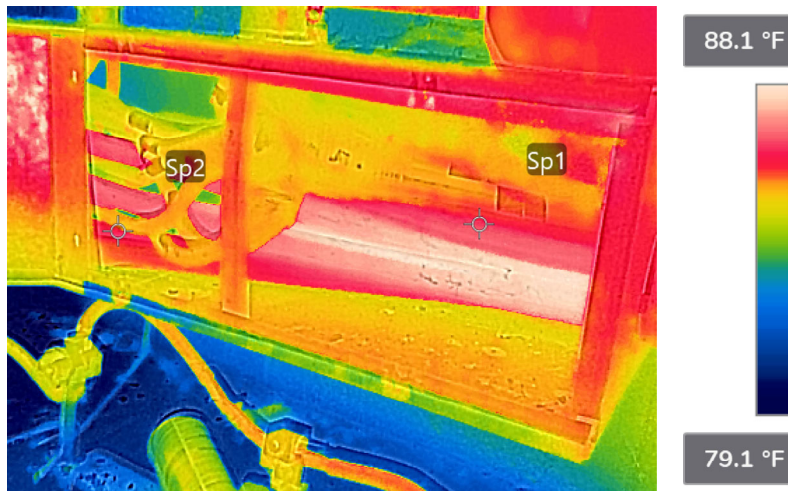
**Knockouts - Missing Knockout seals electrical equipment has exposed energized access, person or object may suffer electrocution if in contact with opening in contactor box, Recommend by code all knockouts should be installed. Please ask your electrician/engineer to evaluate**

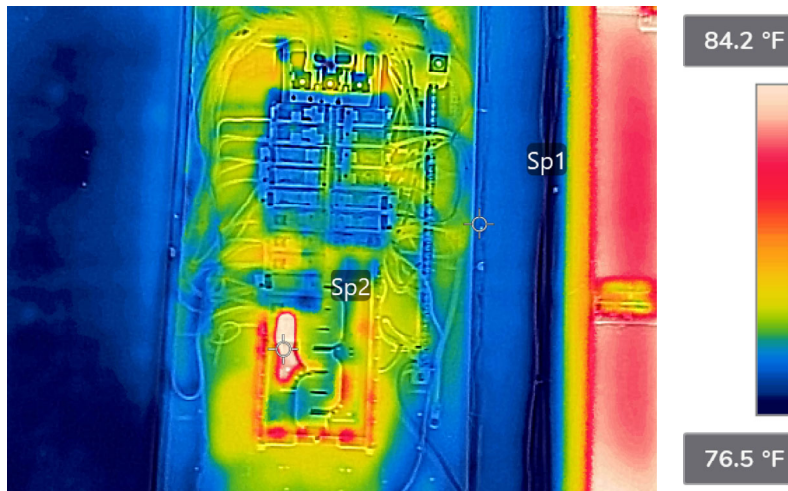
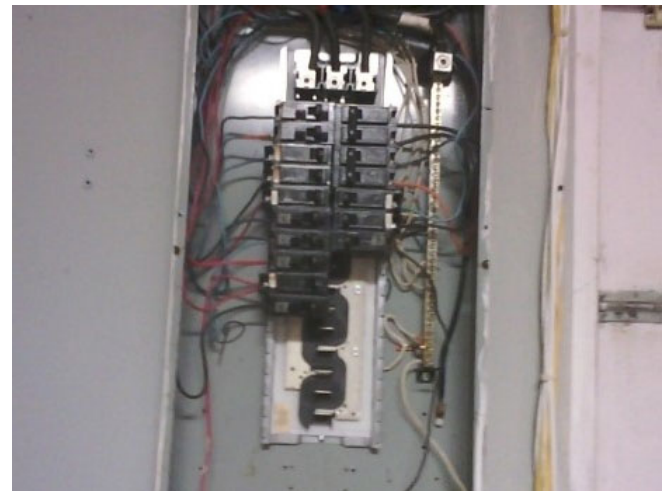
**Doble tapping Breakers, Recommend liscence electrician to repair**

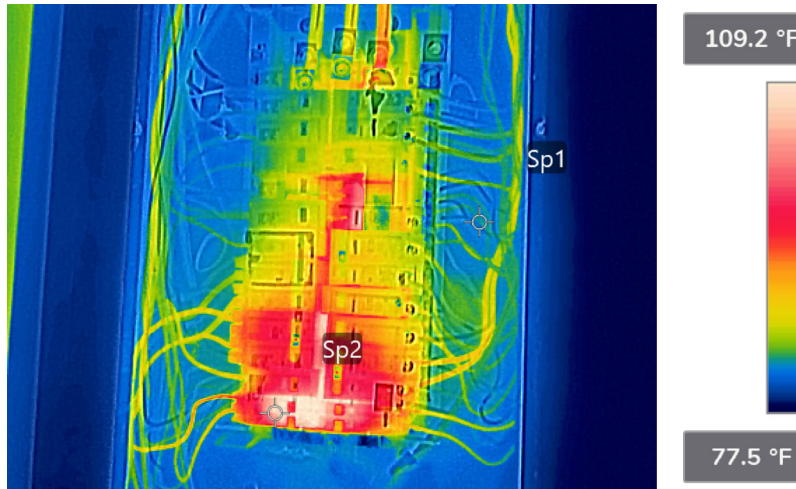
**Doble tapping Breaker Ground issues and missing breaker cover, Recommend licence electrician to repair**

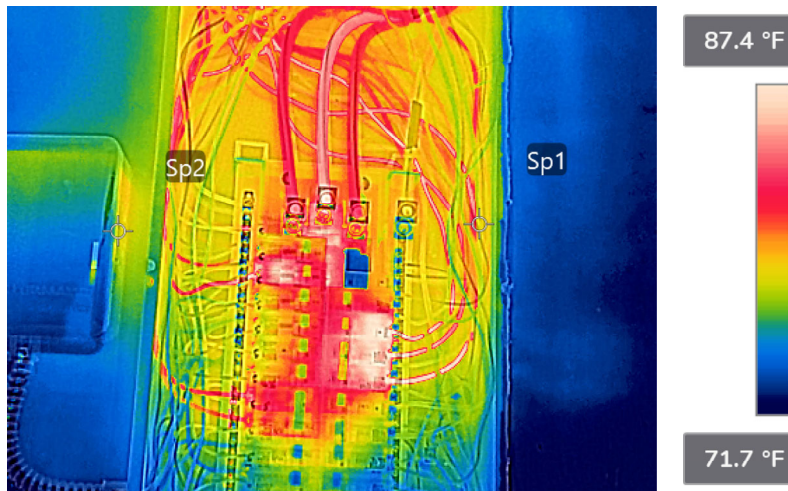
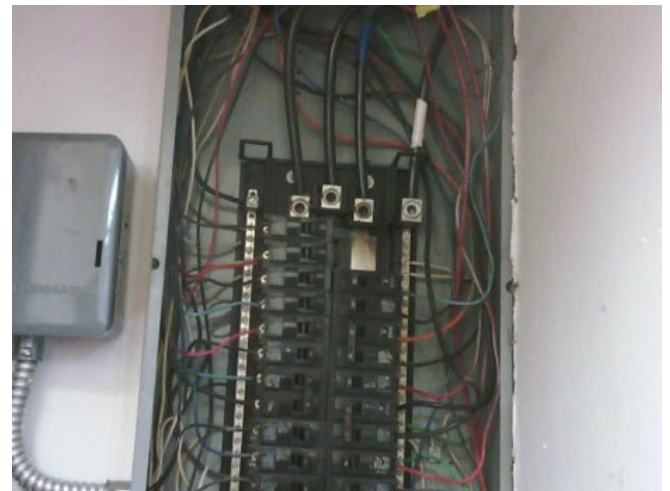
**Grounding Issues, Recommend installing proper grounding bars by a liscence electrician**

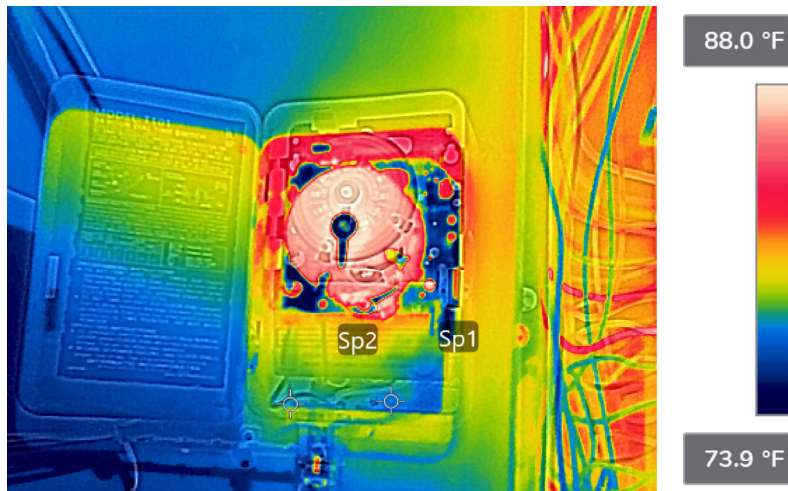
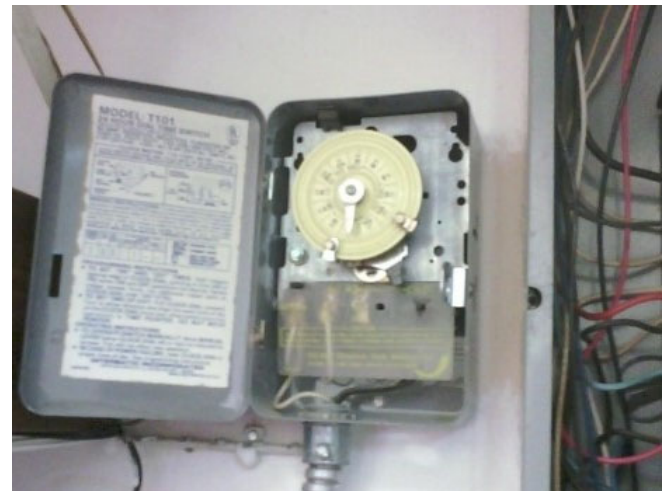
**No heat rise. Higher temperature is reflected from inspector's body**

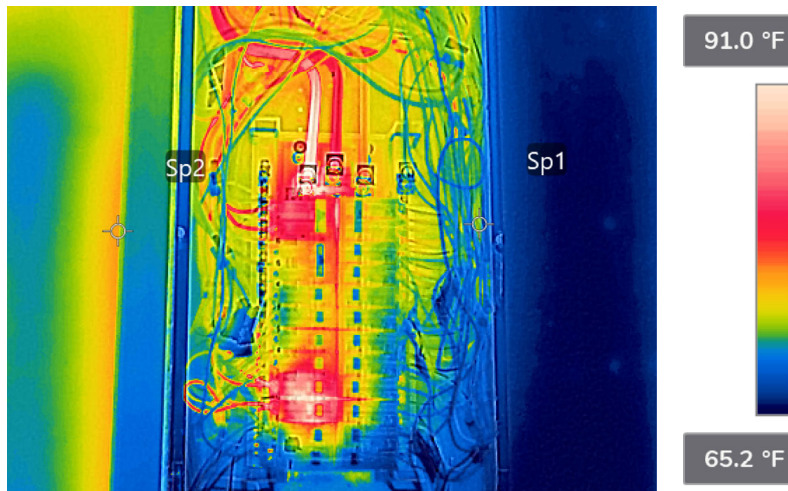
**Double tapping Breaker And grounding issues , Recommend lisencc electrician to repair**
