# Infrared Inspection

## Infrared Thermography Inspection

**40 Year Recertification**

Thermographer	Humberto Suarez
Company Name	Evolve Property Inspections
Client	Sample
Inspection Date	03/24/2022
Address	Sample
Report Name	Electrical Thermography

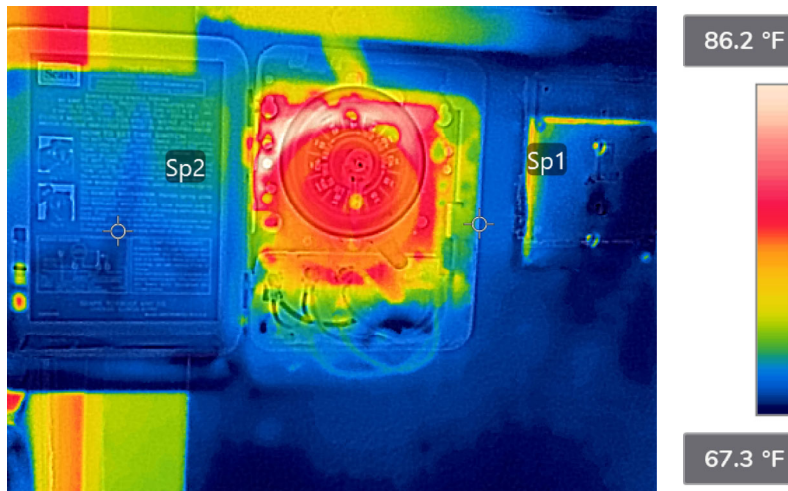
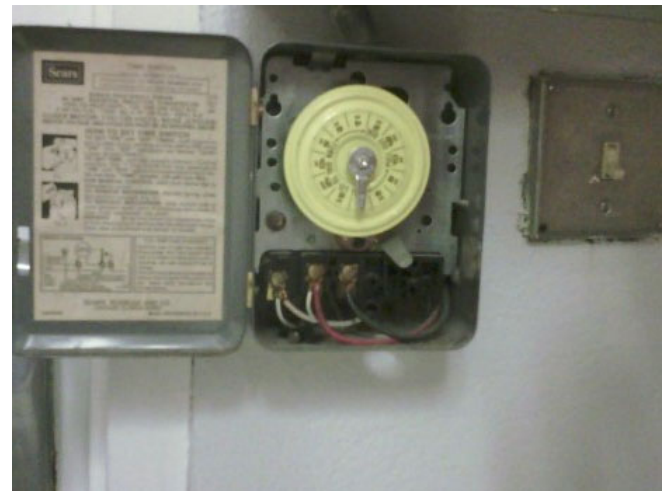
**No heat rise. Higher temperature is reflected from inspector's body**

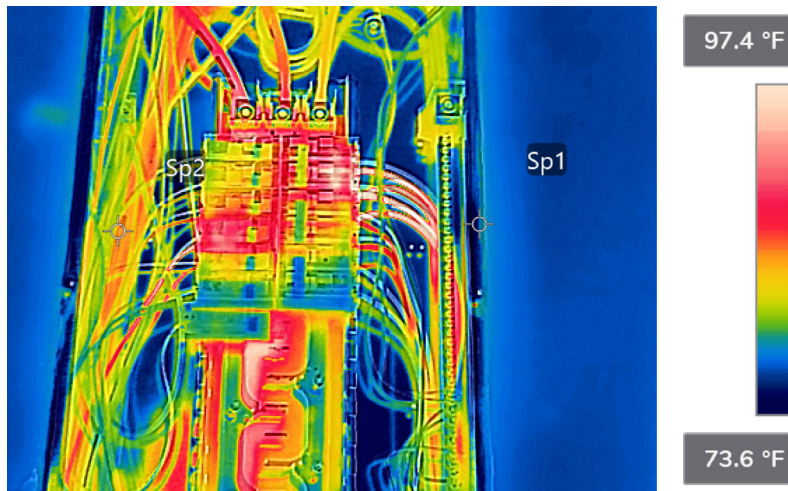
**Double tapping and grounding issues recommend electrical contractor**

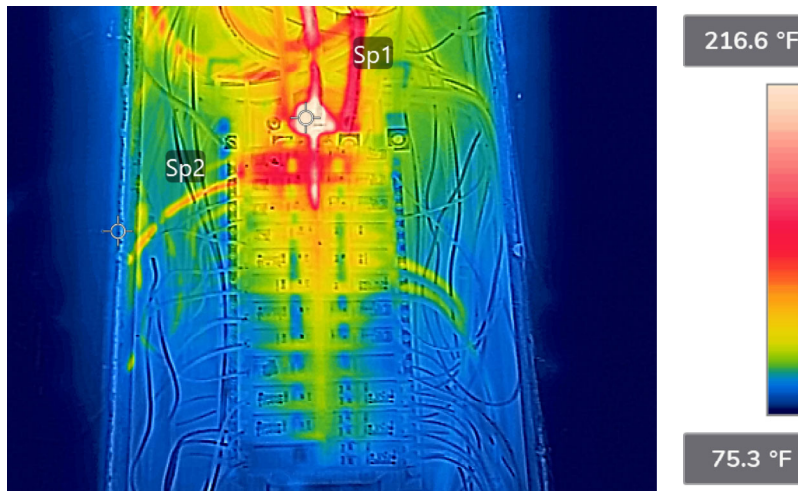
**Fire hazardous 1 phase burnt, Recommend replacement of breaker panel and breakers**

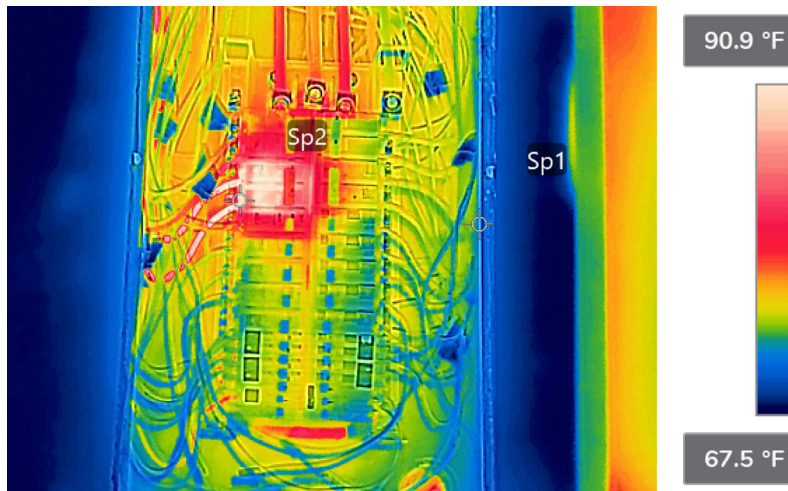
**Doble tapping Breaker And grounding issues , Recommend electrical contractor**

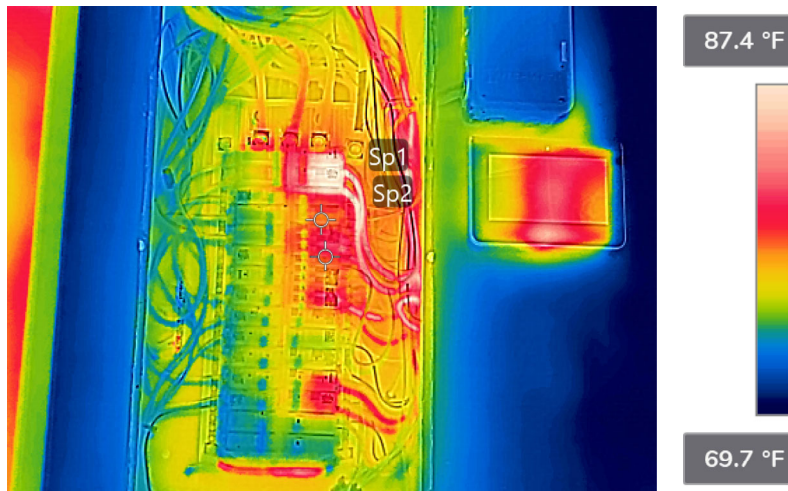
**No heat rise. Higher temperature is reflected from inspector's body**

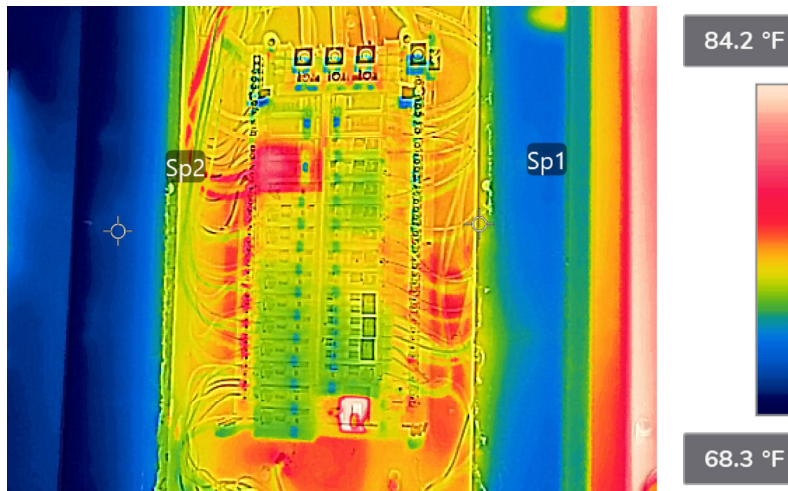
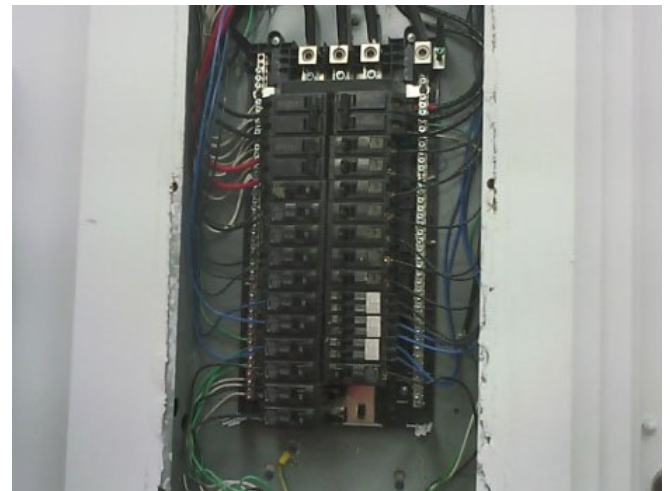
**Grounding Issues, Recommend installing proper grounding bars by a liscence electrician**

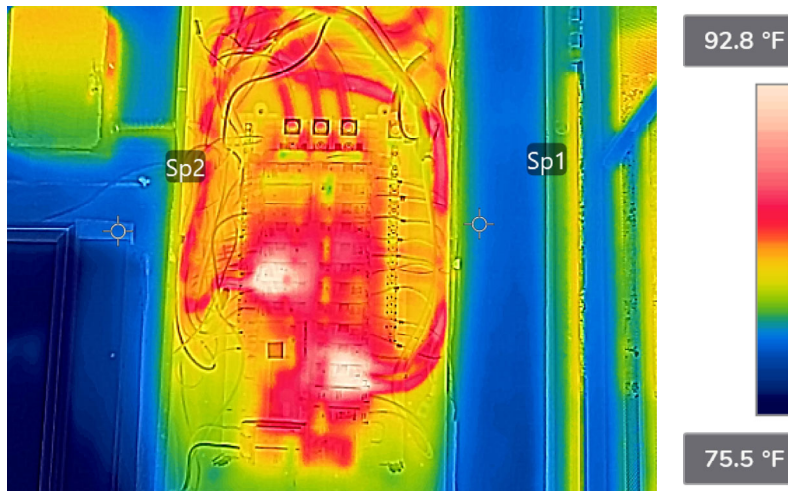
**Grounding Issues Romex connector missing, Recommend installing proper grounding bars by a licence electrician and connectors**

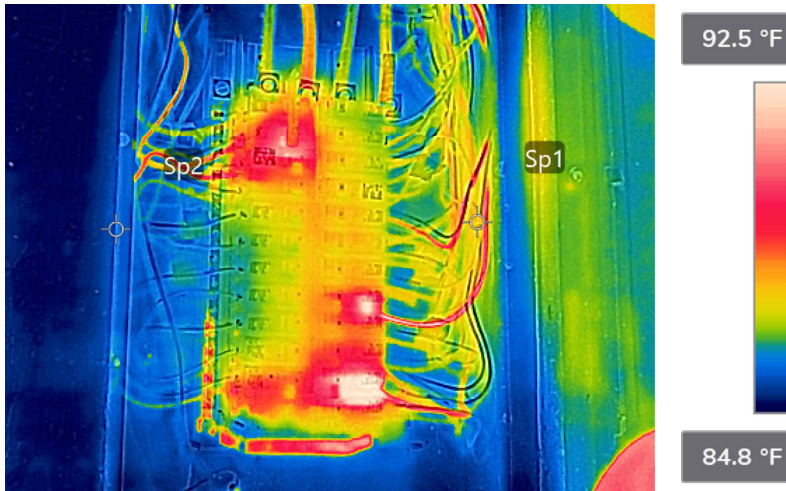
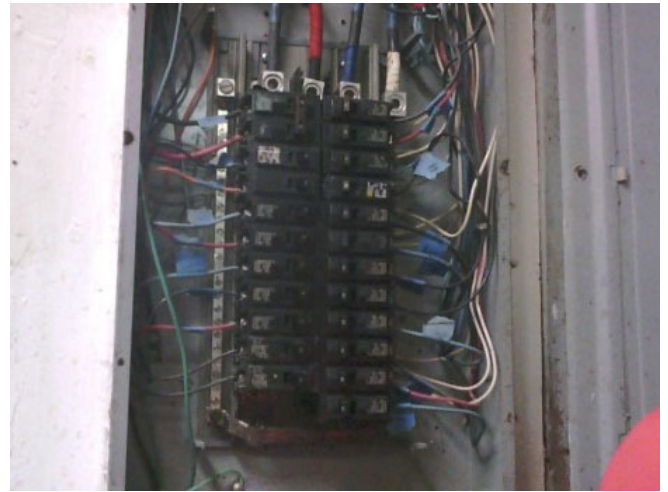
**Grounding issues, Recommend electrical contractor installing properly ground bar**

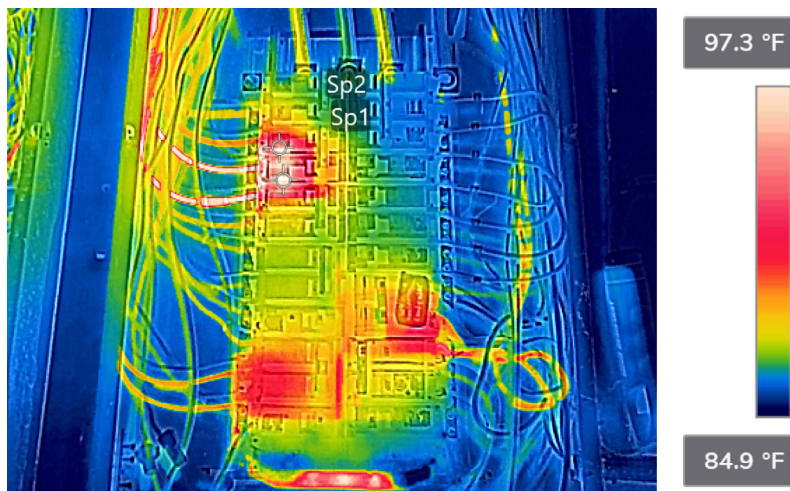
**No heat rise. Higher temperature is reflected from inspector's body**
