Infrared Inspection

Infrared Thermography Inspection **Building Recertification** Electrical system operating at 400A or higher

Inspection Details	
Thermographer	Humberto Suarez
Company Name	Evolve Property Inspections
Client	SAMPLE
Inspection Date	August 29th, 2024
Address	00 NW 000th St Miami, Florida
Report Name	Electrical Thermography

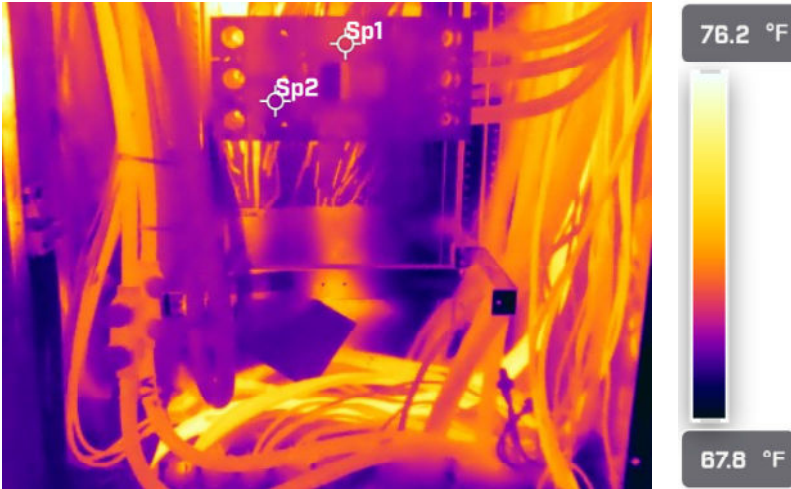
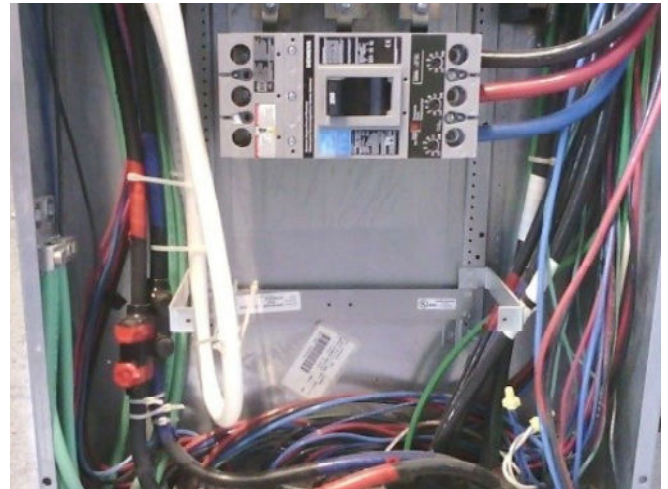
Sp1	70.6 °F
Sp2	69.9 °F
Temp Rise over Ambient	
Sp1-Reference temp.	70.6 °F
Temp Rise over similar	
Sp1-Sp2	0.8 °F
Emissivity	0.95
Reflected temp.	68.0 °F
Atmospheric temp.	68.0 °F

Severity: **Normal**

Floor	1
Location	Electrical Room
Equipment	MDP Bottom
Item	1
Details	Y
Anomaly	Normal
Recommendation	No action

No thermal anomalies or deficiencies found during initial inspection.

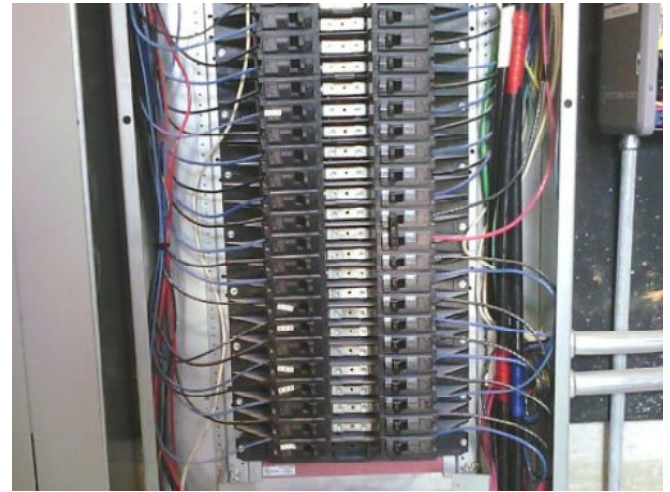
Sp1	69.6 °F
Sp2	69.6 °F
Temp Rise over Ambient	
Sp1-Reference temp.	69.6 °F
Temp Rise over similar	
Sp1-Sp2	0.0 °F
Emissivity	0.95
Reflected temp.	68.0 °F
Atmospheric temp.	68.0 °F

Floor	1
Location	Electrical Room
Equipment	Breaker Panel Bottom
Item	Panel LA
Details	Y
Anomaly	Normal
Recommendation	No action

Severity: **Normal**

No thermal anomalies or deficiencies found during initial inspection.

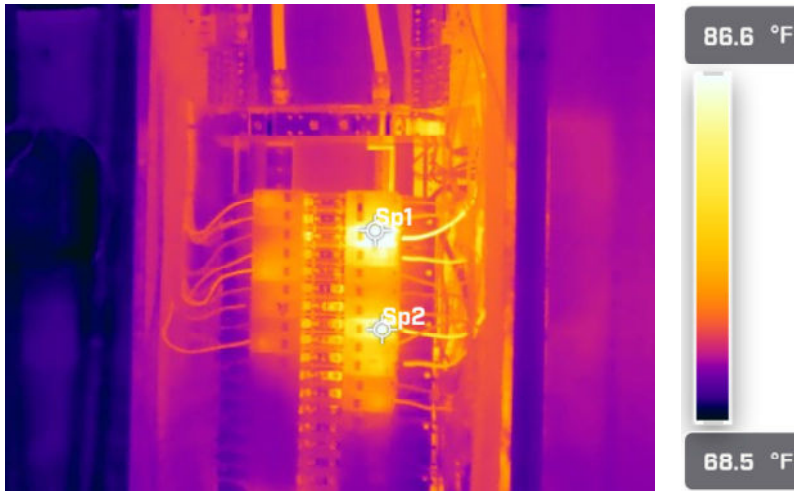
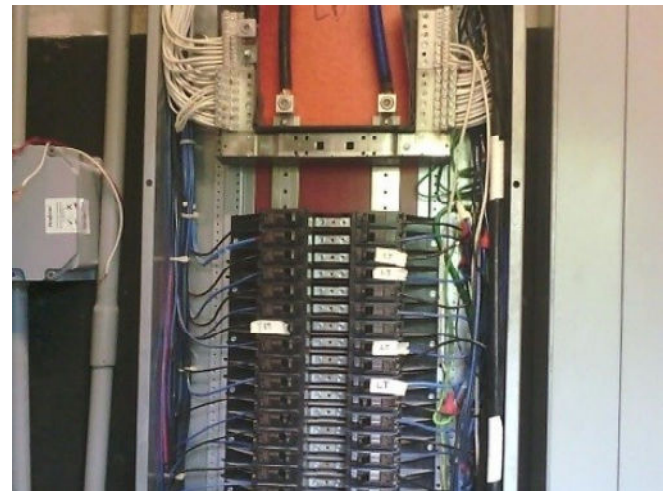
Sp1	89.4 °F
Sp2	88.8 °F
Temp Rise over Ambient	
Sp1-Reference temp.	89.4 °F
Temp Rise over similar	
Sp1-Sp2	0.6 °F
Emissivity	0.95
Reflected temp.	68.0 °F
Atmospheric temp.	68.0 °F

Floor	1
Location	Electrical Room
Equipment	Breaker Panel Top
Item	Panel LB
Details	Y
Anomaly	Normal
Recommendation	No action

Severity: **Normal**

No thermal anomalies or deficiencies found during initial inspection.

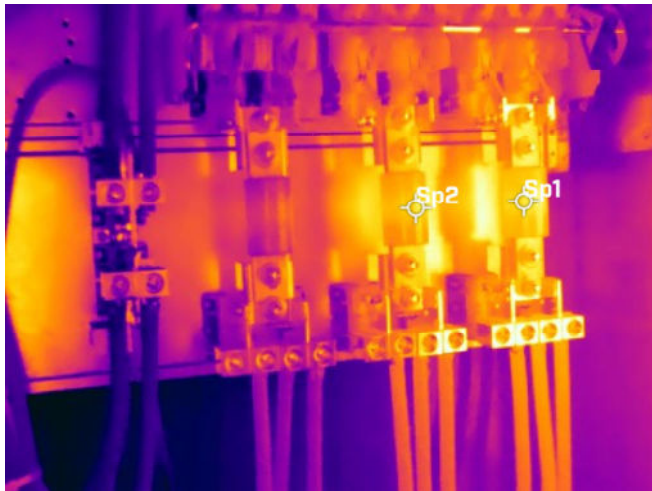
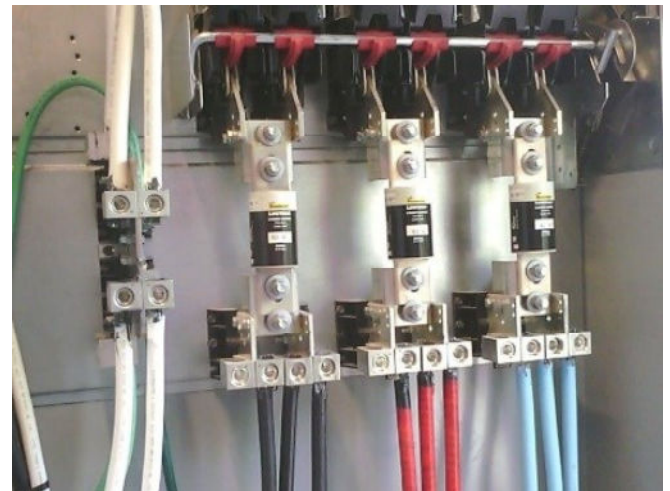
Sp1	78.0 °F
Sp2	78.1 °F
Temp Rise over Ambient	
Sp1-Reference temp.	78.0 °F
Temp Rise over similar	
Sp1-Sp2	-0.1 °F
Emissivity	0.95
Reflected temp.	68.0 °F
Atmospheric temp.	68.0 °F

Floor	1
Location	Electrical Room
Equipment	800AMP Main Fuse Disconnect
Item	Main 1 of 1
Details	Y
Anomaly	Normal
Recommendation	No action

Severity: **Normal**

No thermal anomalies or deficiencies found during initial inspection.

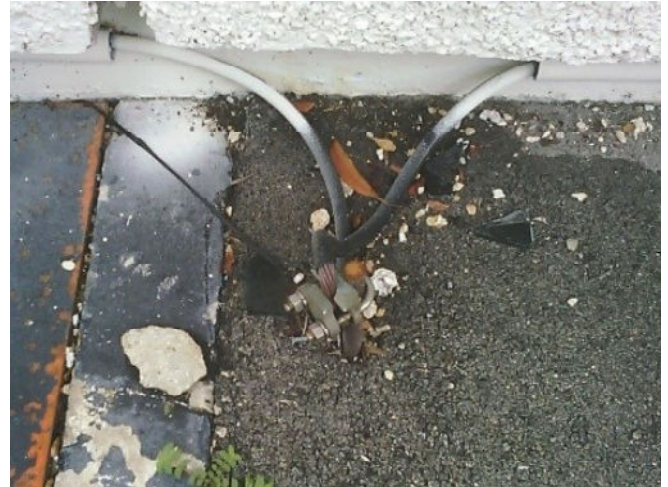
Sp1	81.4 °F
Sp2	81.6 °F
Temp Rise over Ambient	
Sp1-Reference temp.	81.4 °F
Temp Rise over similar	
Sp1-Sp2	-0.1 °F
Emissivity	0.95
Reflected temp.	68.0 °F
Atmospheric temp.	68.0 °F

Floor	1
Location	Electrical Room
Equipment	Grounding Rod
Item	1
Details	Y
Anomaly	Normal
Recommendation	No action

Severity: **Normal**

No thermal anomalies or deficiencies found during initial inspection.
