# Infrared Inspection

## Infrared Thermography Inspection

**40 Year Recertification**

Thermographer	Humberto Suarez
Company Name	Evolve Property Inspections
Client	Sample
Inspection Date	03/24/2022
Address	Sample
Report Name	Electrical Thermography

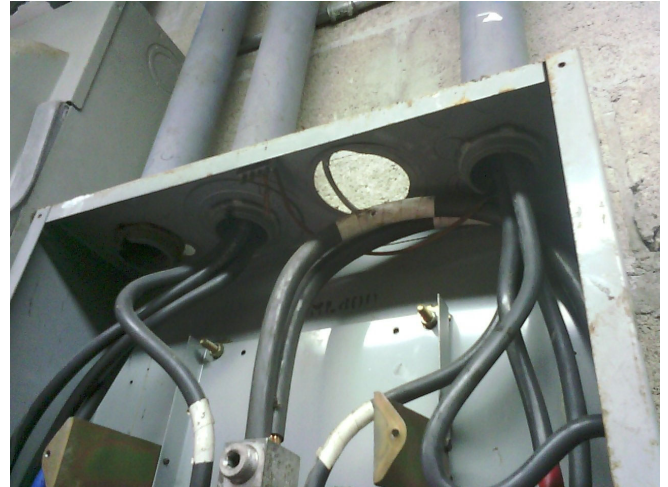
**No Ground and one main breaker not in use, Recommend electrical contractor to evaluate and repair**

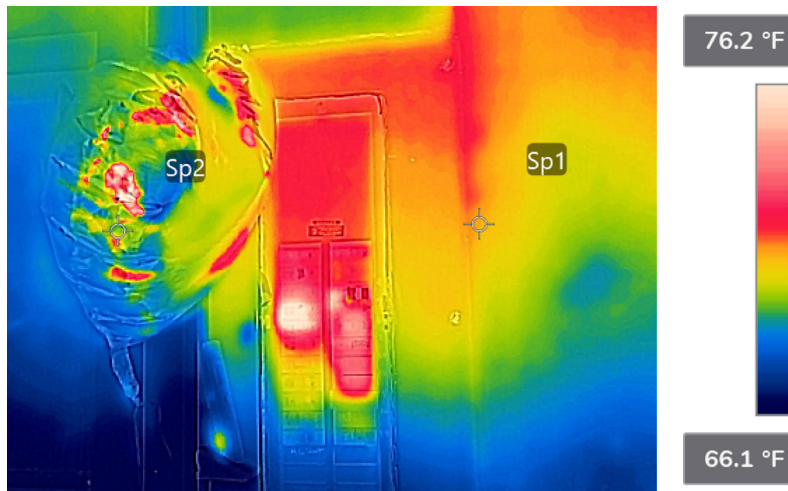
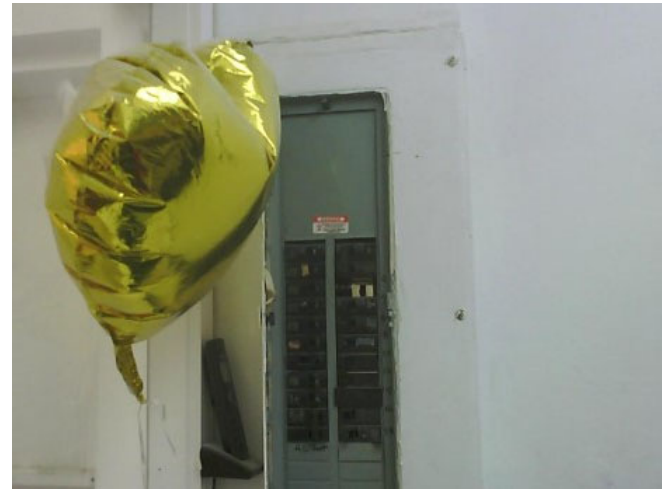
Sp1	71.0 °F
Sp2	69.7 °F
Sp1-Sp2	1.3 °F
Sp1-Reference temp.	71.0 °F
Emissivity	0.90
Reflected temp.	68.0 °F
Atmospheric temp.	79.0 °F
Reference temp.	0.0 °F

Normal	0 to 1
Intermediate	1 to 4
Repair next time	4 to 15
Repair immediately	>15

Floor	1
Location	11929
Equipment	Breaker panel 3
Details	NI
Anomaly	Priority
Recommendation	Panel not available for open

**No access to panel wall blocking, Recommend contractor to evaluate for proper access**
